## SmartDitch Stops Erosion in Goldsboro, NC Neighborhood

On a recent project in Goldsboro, NC, SmartDitch was installed in a residential area that had drainage and erosion problems. A 15" concrete culvert pipe was discharging (storm water) into an earthen ditch behind houses and during heavy rain events washing out their yards. In the past, rip rap had been placed at the end of the culvert pipe to dissipate the energy of the flow with limited success. The local municipality reviewed and chose SmartDitch as a solution to stop the erosion and improve the drainage situation.

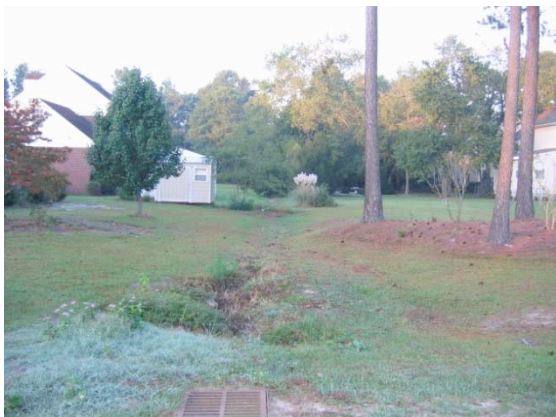
*(Earthen ditch behind homes in Goldsboro, NC)*

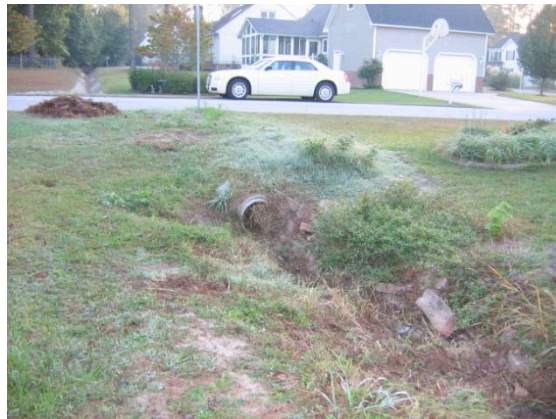
*(The 15" culvert pipe that discharges into the ditch)*

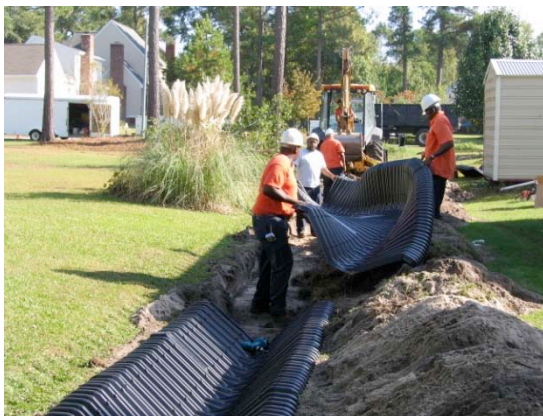
*(City of Goldsboro Crews installing SmartDitch)*

Starting at the end culvert pipe, 320 lineal feet of 12" trapezoidal SmartDitch was installed to provide a defined drainage channel behind the homes. Installation was performed by the City of Goldsboro Municipal crews and was completed in a couple of days.

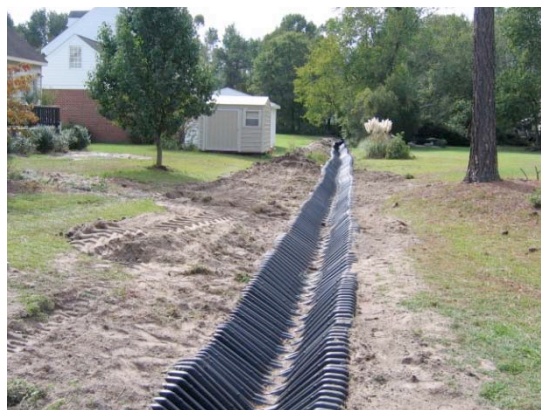
*(320 lf of SmartDitch installed on first day)*

The decision to utilize SmartDitch was tested on the first day of construction. The 320 feet of SmartDitch was installed on the first day and the crew finished the day with only the need to complete finished grading and clean-up on the second day. That evening, a heavy rain event occurred and provided the first test of the new system. In less than two hours, over 3" of rain occurred and overloaded the entire

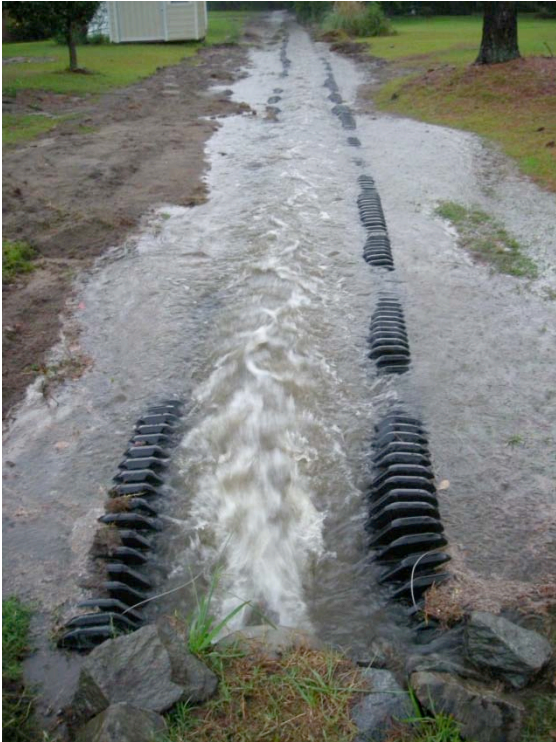
neighborhood drainage system. The 15" concrete culvert pipe emptying into the SmartDitch sections was flowing at 100% capacity during the event with the flows exceeding the 12" Trapezoidal section's flow capacities. The water flowed over the side walls of the SmartDitch sections but because the energy of the flow was dissipated by the corrugated side walls, no erosion occurred. The integrity of the ditch was maintained and the water moved quickly away from the residences, preventing serious flooding and damage. As the rain event subsided, the water that flowed over the sides drained back into the SmartDitch with no erosion occurring on the sides.

*(Water flowing from a 15" Culvert pipe during heavy rain event)*

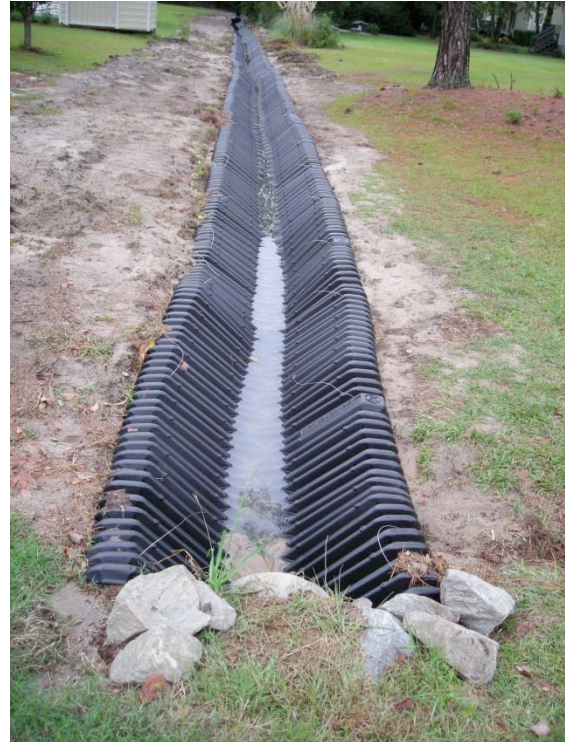
*(The same section of SmartDitch a few hours after the event.)*
