## SmartDitch Helps Wisconsin Community Solve Long-Standing Drainage & Erosion Problem

### **PROBLEM: Lakeside Community Fights Poor Drainage, Battles Roadside Erosion**

### **SOLUTION: Town Board Approves SmartDitch for Permanent Solution**

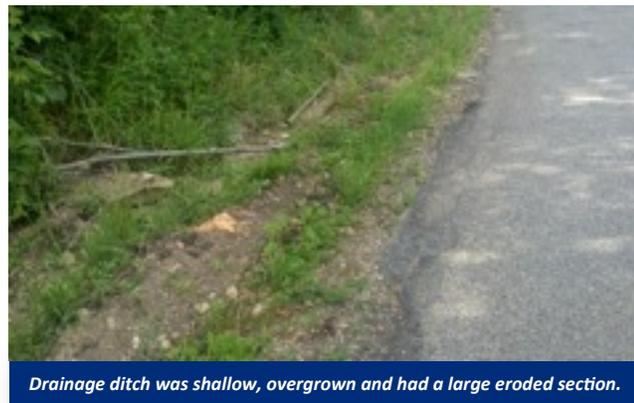
*Drainage ditch was shallow, overgrown and had a large eroded section.*

After inspecting the ditch, Maederer presented a design to reline 130 LF of the earthen channel. The design called for 14 sections of the 12" SmartDitch channel. Each section is 9.5' in long and are overlapped, then joined together (with self-tapping screws), along the length of the ditch. Once in place, the sections are secured to the ground using anchors and stainless steel cables. Estimated installation time was less than a week and it could be done by the town's own maintenance crew. The board unanimously approved the design and expense.

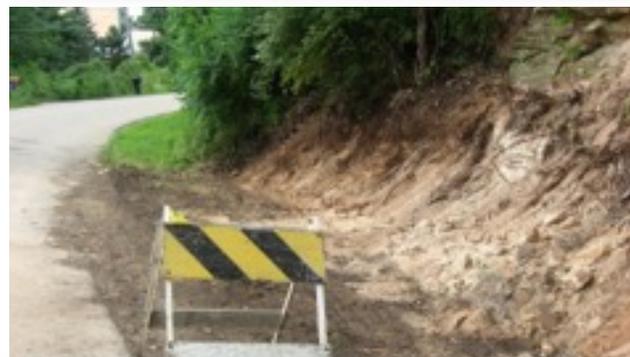
*Sediment from slope erosion spilled onto the roadway.*

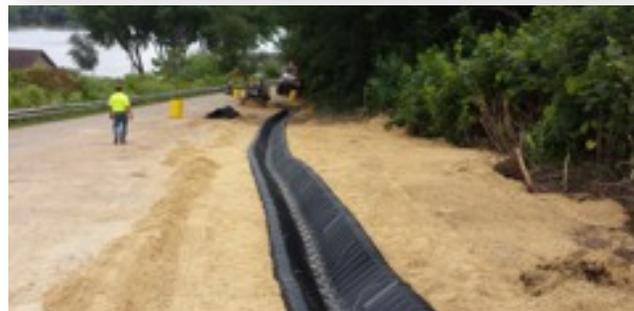
*The town of La Valle's own maintenance crew installed the 12" depth SmartDitch channels.*

SmartDitch Engineers provided installation supervision to ensure the town's maintenance crew installed the product properly. Including ditch cleaning, filling in eroded areas and excavation, the installation took only 5 days to complete.

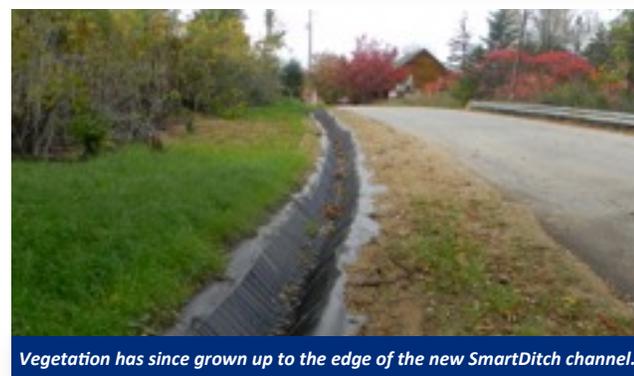
*Vegetation has since grown up to the edge of the new SmartDitch channel.*

For added erosion control, 30 mil HDPE Edge protection was installed on both sides of the channel to prevent erosion along the SmartDitch edges.
