SmartDitch Eliminates Severe Slope-side Erosion at Landfill With 145 ft. Elevation

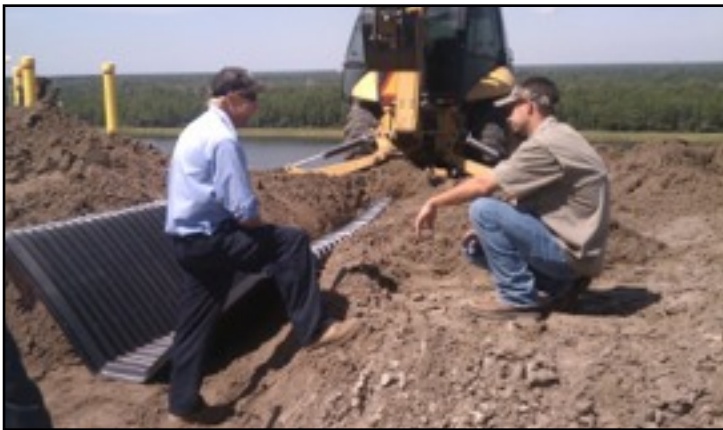
A 500 LF vertical downhill run of 24" depth trapezoidal SmartDitch was installed as the primary stormwater run-off and erosion control channel. Two flared-end sections were added to help guide the water flow at the top, and evenly disperse the run-off water into a rock-line holding area at the bottom.

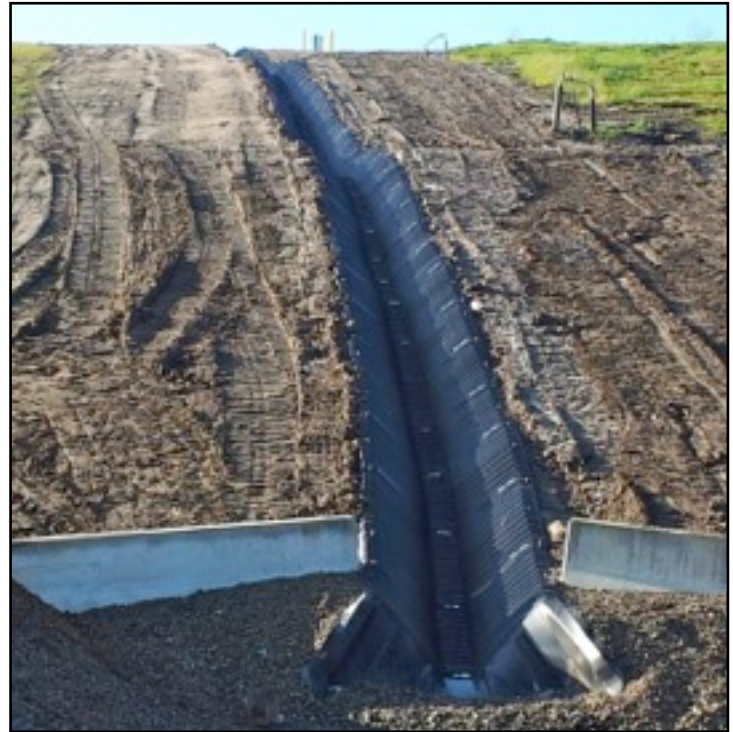
500 LF of 24" SmartDitch was installed to eliminate this landfill's perpetual slope side erosion problems, caused by large amounts of water build-up from the landfill's summit.

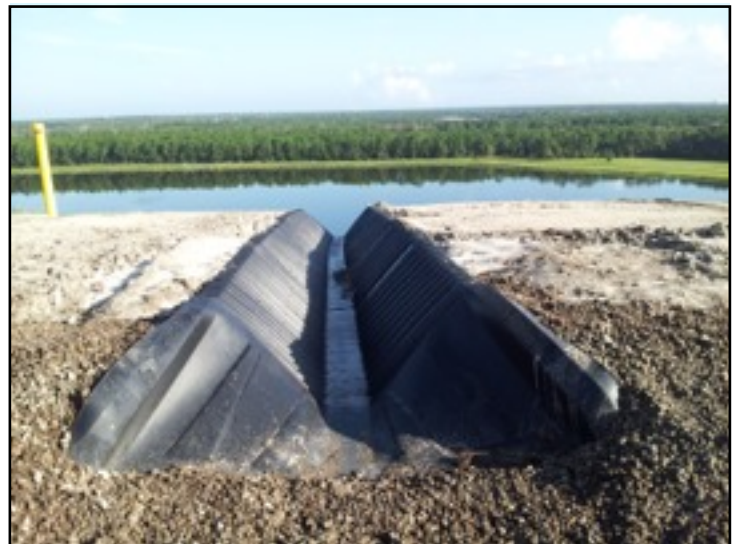
A thermo-formed SmartDitch flared-end section was specified to help direct water flow from the landfill summit.
