## SmartDitch Replaces Failed Rip Rap At MDOT “Park ‘n Ride” Location.

*Instant improvement in stormwater flow and erosion control realized.*

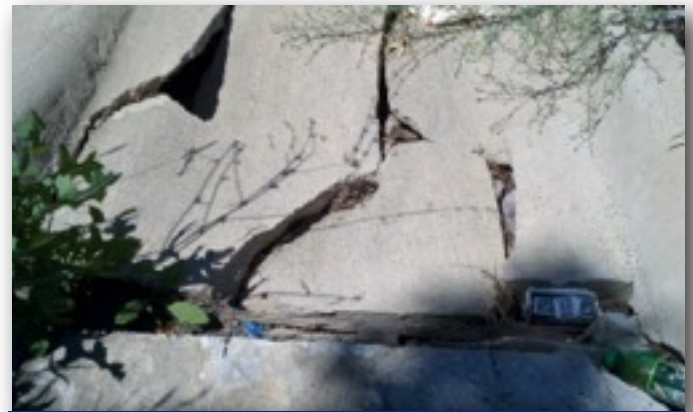
A non-reinforced concrete spillway and multiple rip rap applications failed after one year, causing flooding and erosion at a local Park ‘n Ride commuter location maintained by the MDOT Brighton Service Garage.

*Failed non-reinforced concrete spillway.*

A new reinforced concrete spillway and **SmartDitch** drainage channel was installed to replace the failed N-RCP and the continuously scouring rip rap.

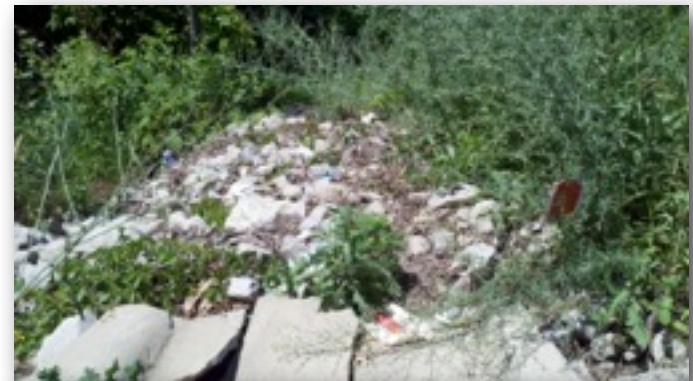
*Rip rap repeatedly failed, and the drainage channel became overgrown.*

70 LF of 24” trapezoidal SmartDitch was to replace the rip rap section of the spillway. It only took two days to install and eliminated a year-round drainage, maintenance, and aesthetic issue. No special equipment was required for installation and the product was delivered from Michigan’s SmartDitch Distributor, St. Regis Culvert, to the site in the back of a standard pick-up truck.

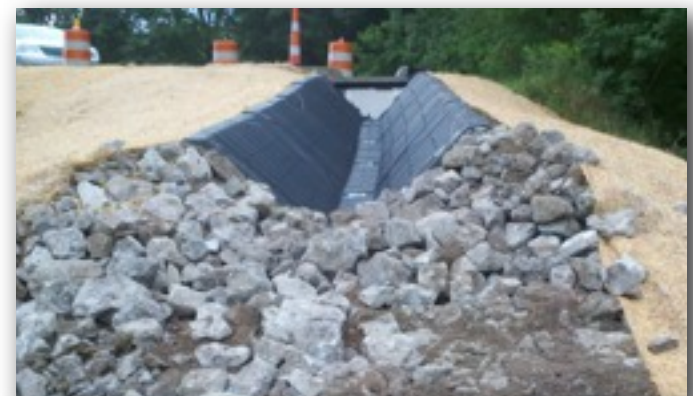
*Completed spill with SmartDitch and repurposed rip rap*

Since SmartDitch is a permanent solution, it is more cost-effective, requires little-to-no maintenance, and will not promote vegetated growth in its channels. Additional savings were achieved by re-purposing the existing rip rap at the downstream end of the SmartDitch channel.
