ERODED RETENTION POND DRAINAGE OUTFALL AT SENIOR CENTER REHABILITATED WITH SMARTDITCH

- ◆ **PROJECT:** Lake Mary Senior Center Retention Pond
- ◆ **SMARTDITCH REPRESENTATIVE:** Joshua Cockayne & Mike Otway, Florida Source, Inc.
- ◆ **PROBLEM:** Exit pipe from drainage inlet causing severe erosion
- ◆ **SOLUTION:** 50' of 24" SmartDitch installed to bring stormwater under control and eliminate erosion
- ◆ **INSTALLATION CONTRACTOR:** All Terrain Tractor Services Orange City, FL
- ◆ **DESIGN ENGINEER:** SmartDitch Civil Engineer Mark Maederer, P.E

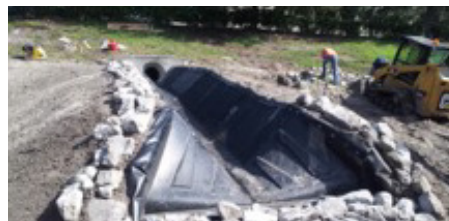
The SmartDitch flared-end section and edge protection further ensure improved drainage and minimal erosion will occur in the future.

Contractor Provides Innovative Installation Technique: To accomplish this task, the installation contractor, All Terrain Tractor Services, removed several tons of rip rap and concrete, re-excavated the disturbed area and created a berm to cradle the SmartDitch. Four sections of SmartDitch were installed and securely anchored into the berm. For this installation, extra anchors were recommended because of the fresh soil conditions of the man-made berm. Finally, SmartDitch flared-end section, further displacing the water's energy, was attached to the downstream end of the channel. Edge protection was also specified to ensure no undermining occurred along the length of each side of the SmartDitch. To complete the installation, some of the old rip rap was re-used to help secure the edge protection.

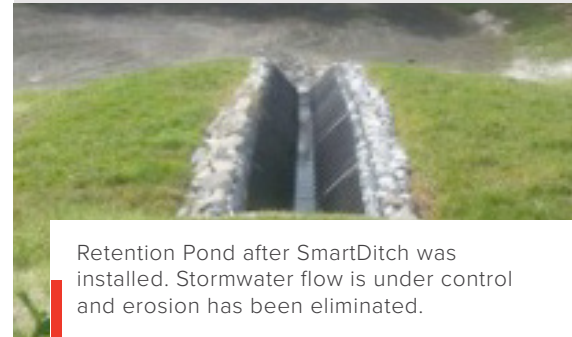
Retention Pond after SmartDitch was installed. Stormwater flow is under control and erosion has been eliminated.

Less than 50 Feet of SmartDitch Solves a Big Erosion Problem: Florida Source, Inc. proposed a design to replace the rip rap by utilizing 50' of 24" trapezoidal SmartDitch. The product's ability to control and channel the run-off would resolve the erosion problem. By attaching the SmartDitch to the headwall, where most of the erosion was occurring, future water run-off will now be carried further into the pond area, dissipating most of the water's energy and minimizing the erosion.

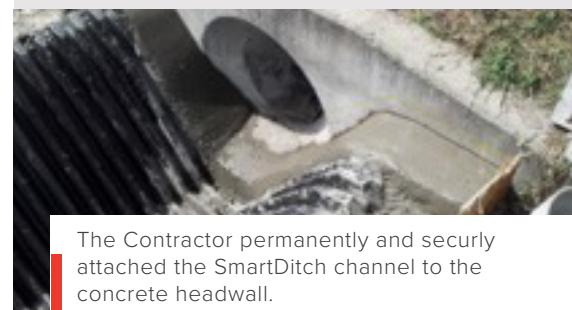
The Contractor permanently and securely attached the SmartDitch channel to the concrete headwall.
