CASE STUDY

PROJECT NAME	Iron Horse Inn Ditch Rehabilitation
PROJECT LOCATION	Durango, Colorado
OWNER	Iron Horse Inn General Manager: Mike McCardell Durango, CO
PRODUCT DETAILS	+600 lf of 24" Trapezoidal Smart Ditch Sections
ANCHORING SYSTEM	Standard Anchors
Joint Type(s):	Gasketed Joint
Fitting(s) used/description:	N/A

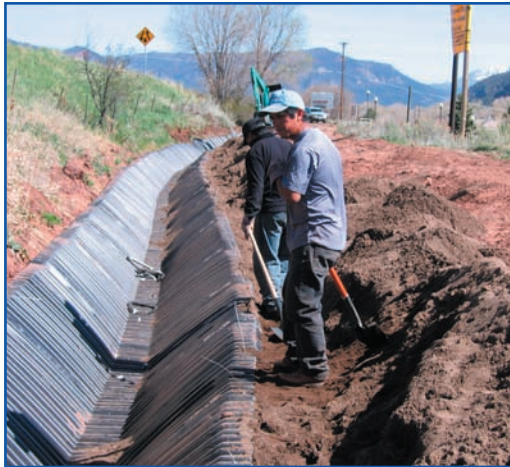
After installing and anchoring the SmartDitch sections, laborers backfill along the sides to match the existing grade.

this task. The course of the ditch snaked along through the right-away requiring the SmartDitch to be installed with several small curves. At each end of the line, SmartDitch was connected to the existing headwalls where the ditch connected to concrete pipe used for road crossings. Sand backfill was brought in to fill in the voids along the sides of the channel sections prior to installation of the anchors.

The installation of the +600 line took approximately 2 days after clearing the vegetation and debris from the existing ditch. The installation crew consisted of two laborers with a Bobcat Skid-Steer loader used to bring in the sand backfill. The curves were installed by offsetting the flowline of the sections a small amount at each joint. The anchors were easily installed using an electric powered hammer.

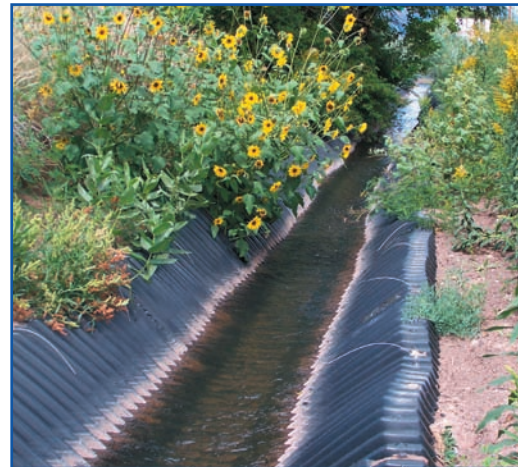
A couple of months after the installation, the natural vegetation has grown right up to the edges of the SmartDitch sections. The natural vegetation combined with the SmartDitch sections provide a stable waterway for the irrigation channel and a strong barrier against erosion on the hillside.

During the following wet season, the water flowed through the lined section with no difficulties and no detectable saturation of the surrounding soil. Because of SmartDitch's HDPE construction, maintenance on this ditch will be minimal, ensuring years of trouble free operation.
